**INTERSECTION SAFETY MASTER PLAN:
INTEGRATED CORRIDOR PLAN -
TRANQUILLE/FORTUNE CORRIDOR**

KAMLOOPS, BRITISH COLUMBIA

September, 2005

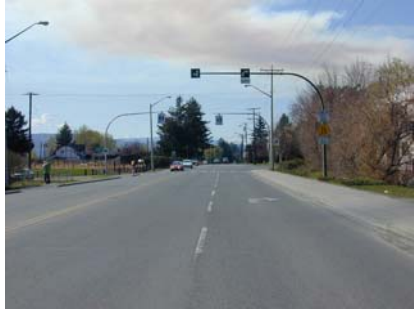
Southill Street	<p>Since westbound left-turn volumes are relatively low, through drivers may not expect leading vehicles to turn left at this location, contributing to rear-end collisions. The eastbound approach is a single lane, with little room for through vehicles to pass by a stopped left turning vehicle and may result in a rear-end or sideswipe collision. Additionally, a through driver may attempt to bypass a left-turn vehicle by entering the right-turn-only lane, contributing to left-turn opposing collisions.</p>

Expected Crash Types: left turn opposing, sideswipe, rear-end

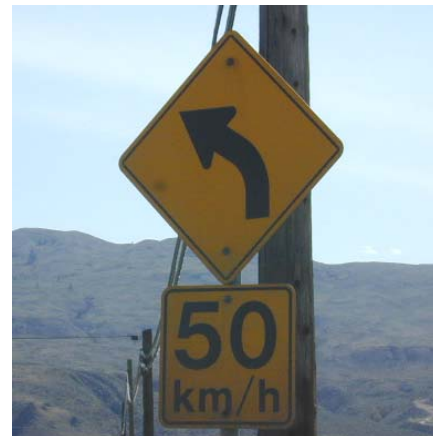
2. *Reflectivity of signs:* This sign, warning of the curve by the airport utilizes engineering grade retro-reflective sheeting. This type of sheeting has limited retro-reflective properties. As a result these devices may not be immediately noticeable to drivers at night, especially in adverse environmental conditions, in cluttered areas or along vertical or horizontal curves. This may contribute to last minute braking or other erratic maneuvers, increasing the potential for rear-end or angle collisions.

Engineering grade curve and speed tab signs

Possible solution: The City may consider providing Diamond Grade reflective sheeting on all warning and regulatory signs.

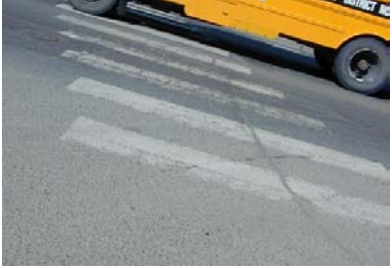
LOCATION	DESCRIPTION AND POSSIBLE COUNTERMEASURES	PHOTOGRAPH
Southill, Larch, Oak, Holt, 8th	<p>Pavement marking, such as pedestrian zebra crosswalks are in poor condition due to excessive wear during the winter months. This may reduce their effectiveness in alerting motorists and pedestrians to exercise caution.</p> <p>The City may wish to renew pavement markings as early as practical in the spring, or use durable pavement marking materials to reduce maintenance needs.</p>

<p style="text-align: center;"><i>Pavement markings at Southill Street</i></p>

Expected Crash Types: rear-end, sideswipe, angle and pedestrian

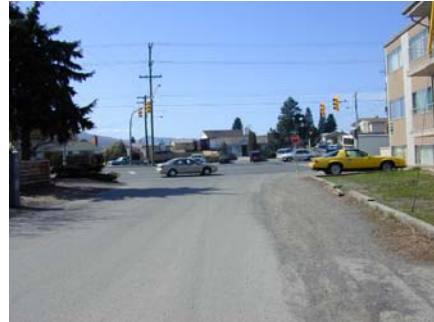
Safety Issue Description: The locations of many private accesses, particularly along side streets on the Tranquille/Fortune corridor are close to intersections. Such accesses may not be conspicuous to approaching drivers or may have limited visibility. Some drivers may fail to anticipate vehicles slowing to turn into the accesses, leading to sudden braking and possibly contributing to rear-end and angle type collisions.

At the east leg at Oak Rd. and Fortune Dr. the driveways and parking are very close to the intersection.

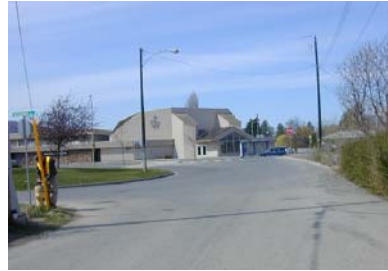
Larch Avenue, looking west past Kitchener Drive to Fortune Drive. The presence of a channelized right turn shortens the weaving distance.

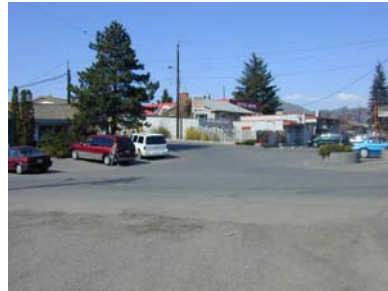
From Oak Road intersection (west leg) looking North to Elm Road. The large area of unmarked pavement and uncontrolled access creates a very large conflict area close to Tranquille Road

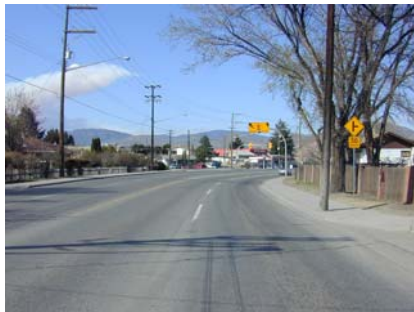
LOCATION	DESCRIPTION OF ISSUE	PHOTOGRAPH
Fortune Drive Larch Street To 7th Street	There are approximately 25 access points from streets and lanes onto Fortune Drive in this 1.5 kilometre section. In addition there are many driveways to access private property. Most accesses permits all movements, resulting in many potential vehicle conflicts and possible collisions.

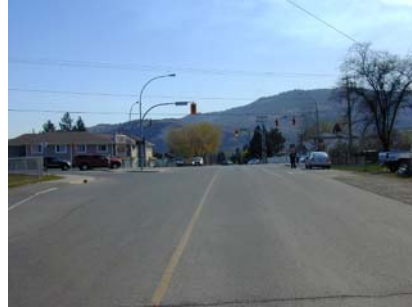
The shallow angle of the right-turn lane means that drivers must crane their necks to look for gaps. This is a difficult manoeuvre, particularly for older drivers, which increases the difficulty for the right-turn drivers to judge available gaps and can reduce the right turn capacity.

Lack of delineation on channelized right-turn lane, combined with a driveway on the exit leg may lead to conflicts

The limited delineation at the exits of the channelized right-turn lanes may cause drivers to incorrectly assume that an acceleration lane is provided, resulting in sudden braking and possibly contributing to rear-end type collisions. Channelized right turns can also contribute to access-related issues, as discussed in Issue 3, and to conflicts with pedestrians, as discussed in Issue 5. Channelized right turns are present at the following locations:

In the long term, the City may wish to redesign the channelized right turn, to optimize the motorists' view of pedestrians and vehicles to their left. The pedestrian crossing should be situated where it is most visible to approaching motorists, typically midway along the curve. A diagrammatic layout of the common design and also the recommended design are shown in FIGURE B.1.

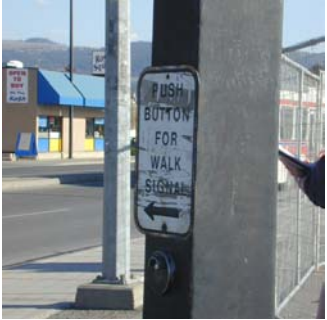
LOCATION	ISSUE	PHOTO
Eighth Street	Some crosswalks at the intersection have older, smaller push buttons. The elderly may find it difficult to activate the small push buttons on the activated crosswalks and so may cross without pressing them. The City may wish to consider providing larger, more accessible push-buttons and new signs.

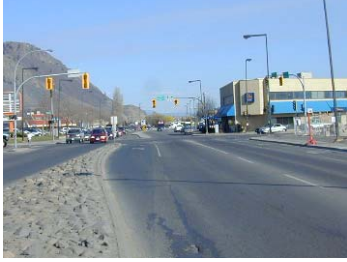
8 th /Tranquille/ Fortune	A dedicated right-turn lane is provided on the eastbound approach to 8 th Street. However, traffic volumes are minimal, due to the presence of a connector road that provides the same function. This underutilized lane unnecessarily lengthens the crossing distance for pedestrians, reducing their exposure to conflicts.

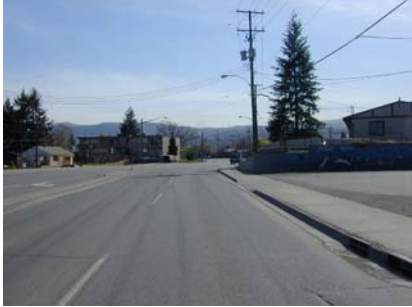
LOCATION	DESCRIPTION OF ISSUE/COUNTERMEASURE	PHOTOGRAPH
Oak Road	<p>The retaining wall restricts the visibility of the upcoming intersection.</p> <p>Provision of advance intersection signing and near-side signal heads may improve visibility of the intersection and signals.</p>

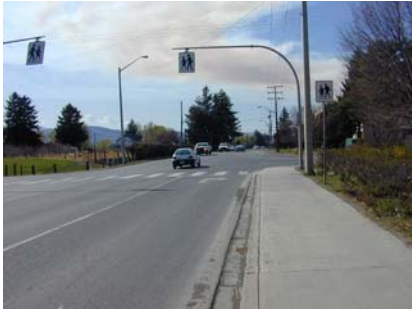
Southill Street	<p>Tranquille Road widens from 1 to 2 lanes east of Southill. The transition (taper) takes place through the far side bus stop. When a bus is loading or unloading it will block the transition area. This may cause eastbound vehicles in the curb lane to suddenly swerve or stop, which may result in a side-swipe or rear-end collision. Consideration can be given for the transition to take place beyond the bus stop. This could be reinforced through additional pavement markings or the construction of a curb extension.</p>

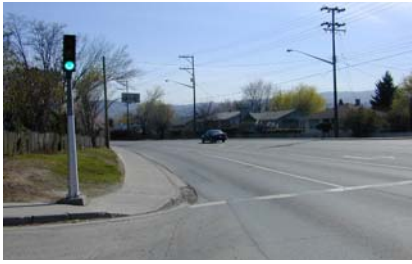
LOCATION	DESCRIPTION OF ISSUE	PHOTOGRAPH
Oak Road	Traffic entering Fortune Road from the east leg of Oak Street has restricted sight distance to the south due to the curve in the roadway. Similarly traffic entering from the west leg has sight restrictions to the north. This issue will be remedied by the installation of a full traffic signal.

<p style="text-align: center;">Looking south from the east leg of Oak St.</p>
Southill Street	<p>Northbound sight distance to the west is restricted by vegetation. Trimming or removal of the vegetation will improve the sight line.</p> <p>Southbound traffic has sight distance restrictions to the east that may be improved by the trimming of some landscape plantings.</p>

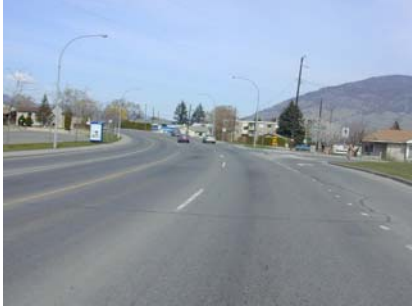
<p style="text-align: center;">Looking east from the north leg</p>
Larch Avenue	Eastbound left turn traffic at Larch has sightlines reduced to the north by the curve. Sight lines to the south may be adequate but driver judgement may be complicated by the speed of oncoming vehicles, curve and the bridge abutments.

<p style="text-align: center;">Curve to the north of Larch St.</p>
