**INTERSECTION SAFETY MASTER PLAN:
INTEGRATED CORRIDOR PLAN -
TRANQUILLE/FORTUNE CORRIDOR**

KAMLOOPS, BRITISH COLUMBIA

September, 2005

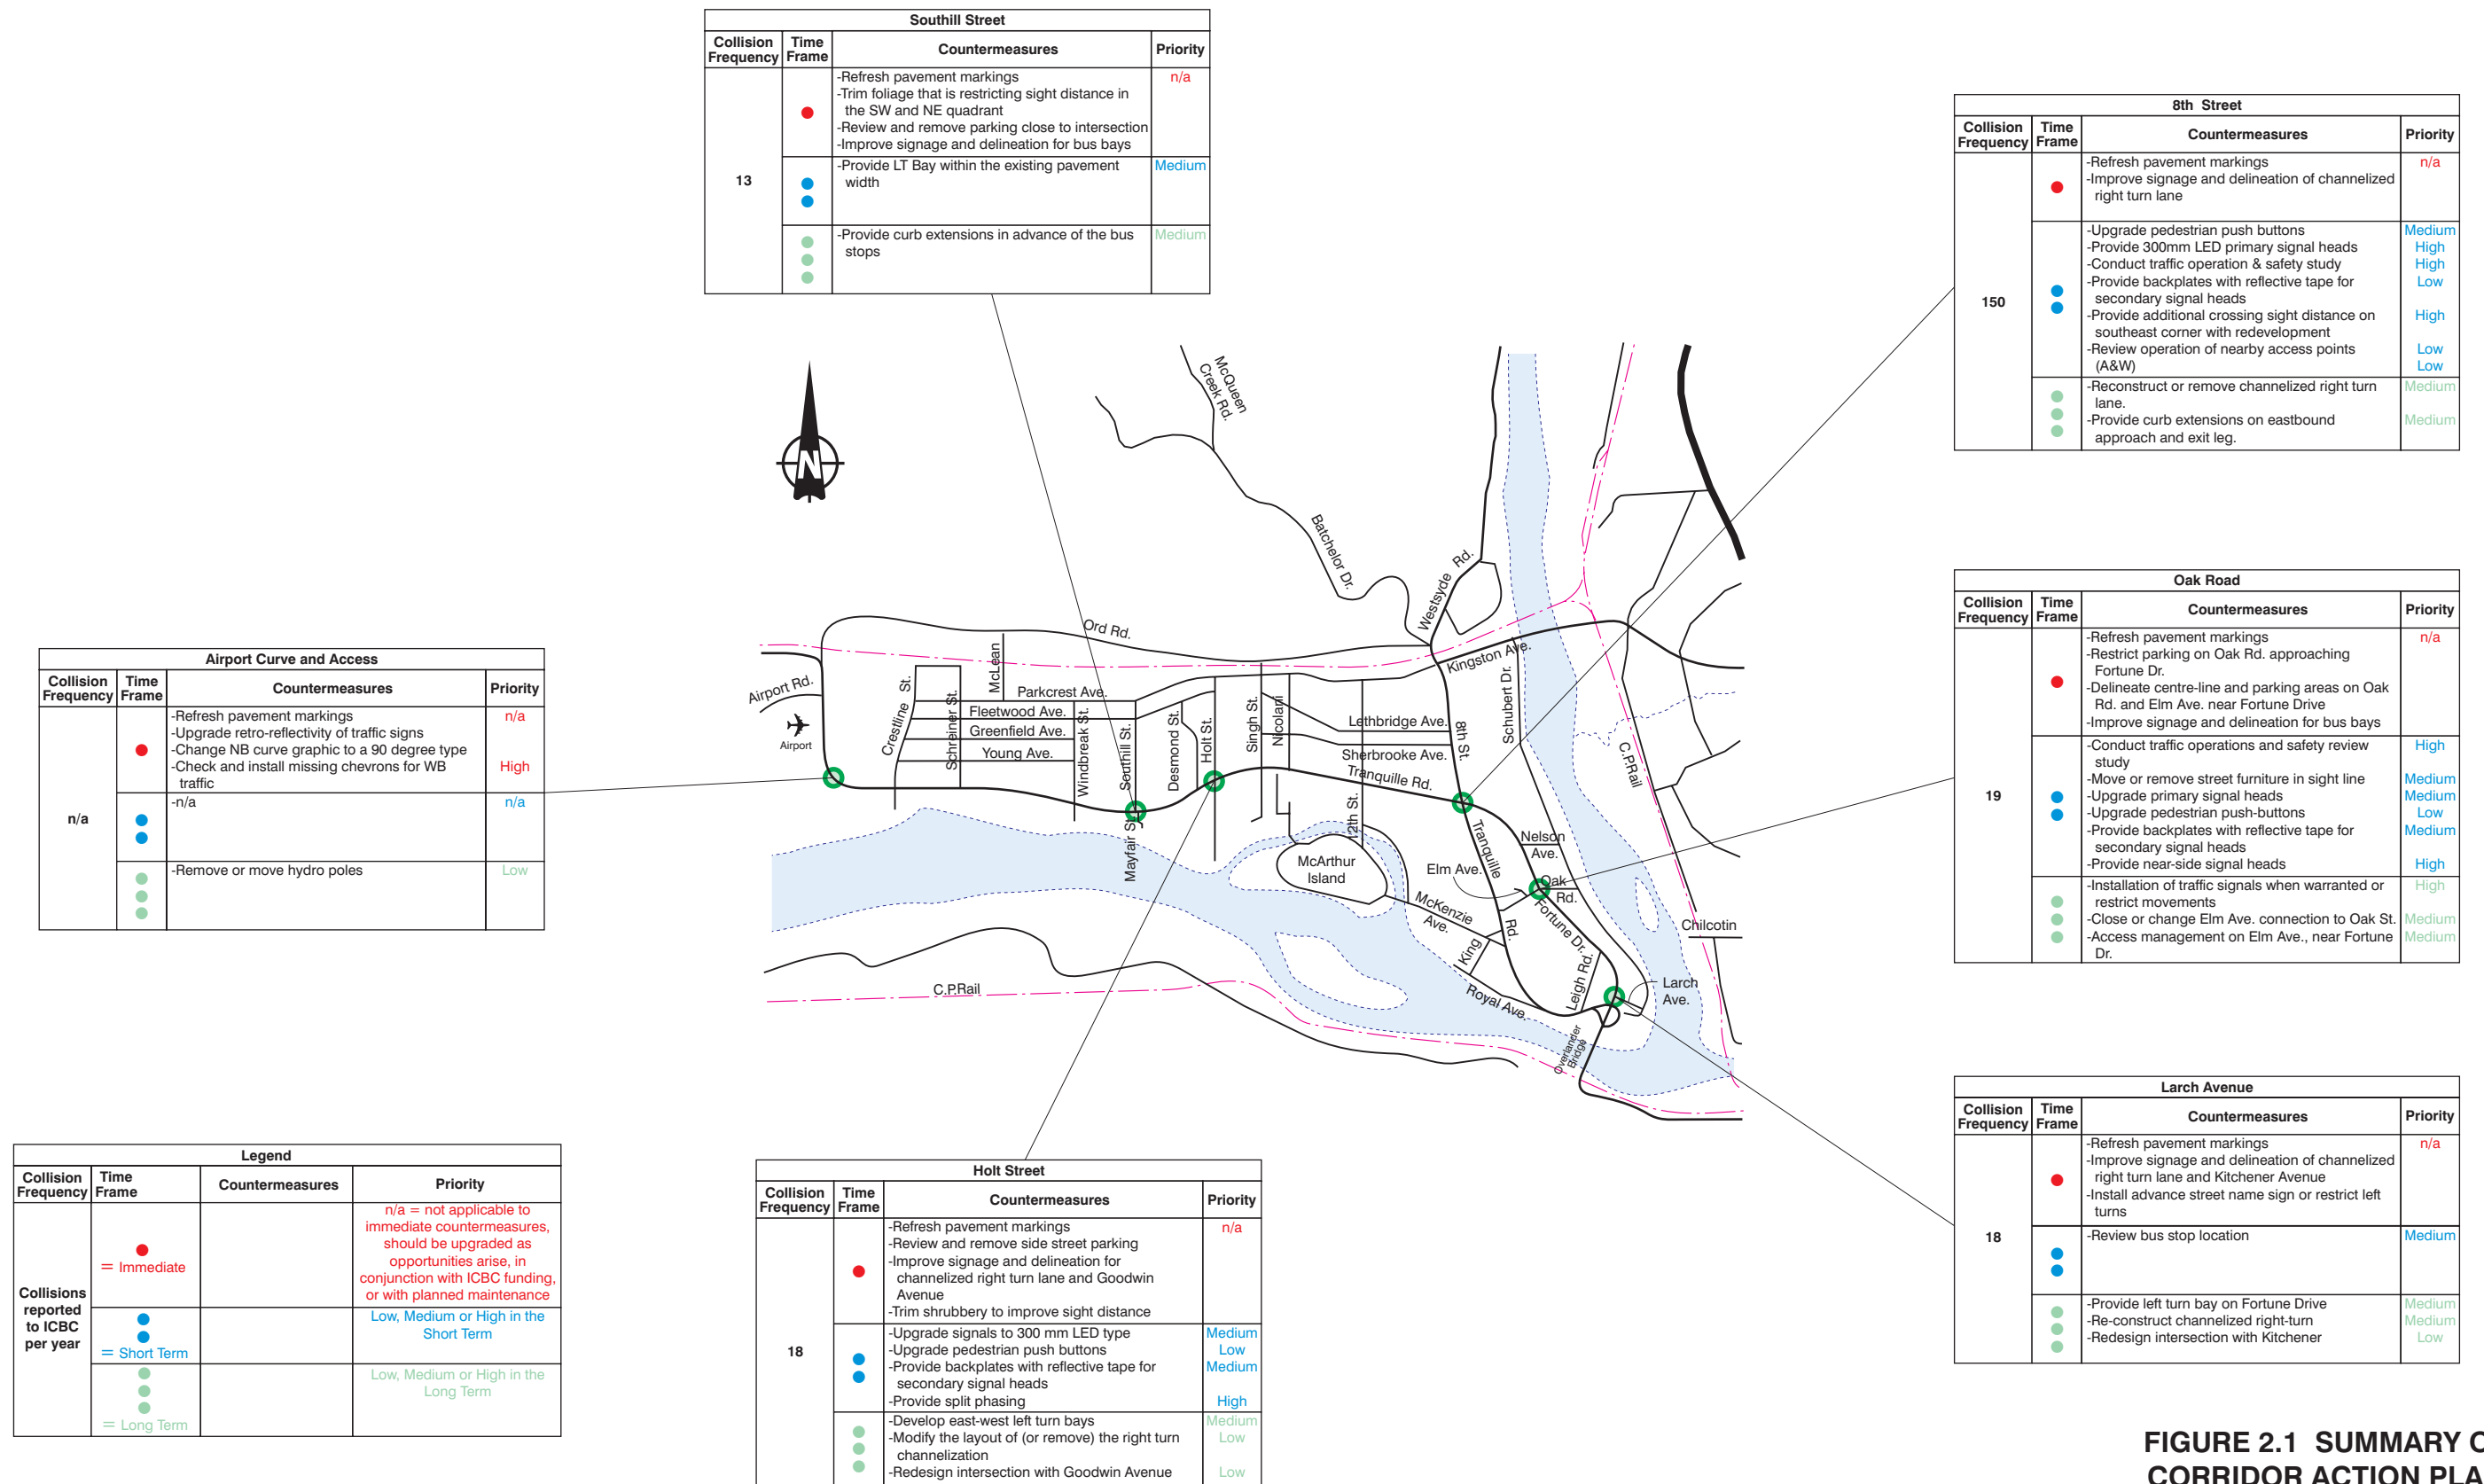
FIGURE 2.1 SUMMARY OF CORRIDOR ACTION PLAN

For each intersection, immediate, short-term and long-term engineering countermeasures were identified. The results are summarized for each study location in FIGURE 2.1, and a priority is also assigned to each of the short-term and long-term countermeasures in FIGURE 2.1.

Immediate term improvements, which are summarized in TABLE 2.7, were identified as mitigating measures that could be immediately implemented at relatively low cost, and with minimal equipment mobilization. Opportunities may exist to incorporate some of the immediate mitigating measures as part of planned roadworks or regularly scheduled maintenance. Therefore, no particular priority was assigned to any of the immediate countermeasures in FIGURE 2.1. A priority is assigned to short and long term countermeasures however.

LONG TERM COUNTERMEASURES	LOCATION						ITEMS TO CONSIDER TO SUPPORT MEASURE
	LARCH	OAK	EIGHTH	HOLT	SOUTHILL	AIRPORT CURVE	
Provide left turn bay(s) through widening	✓			✓			Left-turn opposing and sideswipe collisions
Remove or relocate more hazardous power-pole installations						✓	Pedestrian or fixed-object collisions
Reduce the angle of the channelized right-turns	✓		✓	✓			Right-turn rear-end collisions, pedestrian collisions
Signal installation or restriction of movements		✓					Angle collisions and pedestrian collisions, signal warrants
Review driveway operations and relocate/restrict movements where possible		✓	✓	✓			Sideswipe and angle collisions
Relocate or redesign intersecting roads close to the intersection.	✓	✓		✓			Angle collisions on side street
Provide curb extensions			✓		✓		Compatibility with long term plans, sideswipe and pedestrian collisions
